UNDERWATER BRIDGE INSPECTION REPORT

STRUCTURE NO. 7097

RED RIVER OF THE NORTH

MINNESOTA DEPARTMENT OF TRANSPORTATION
UNDERWATER BRIDGE INSPECTION

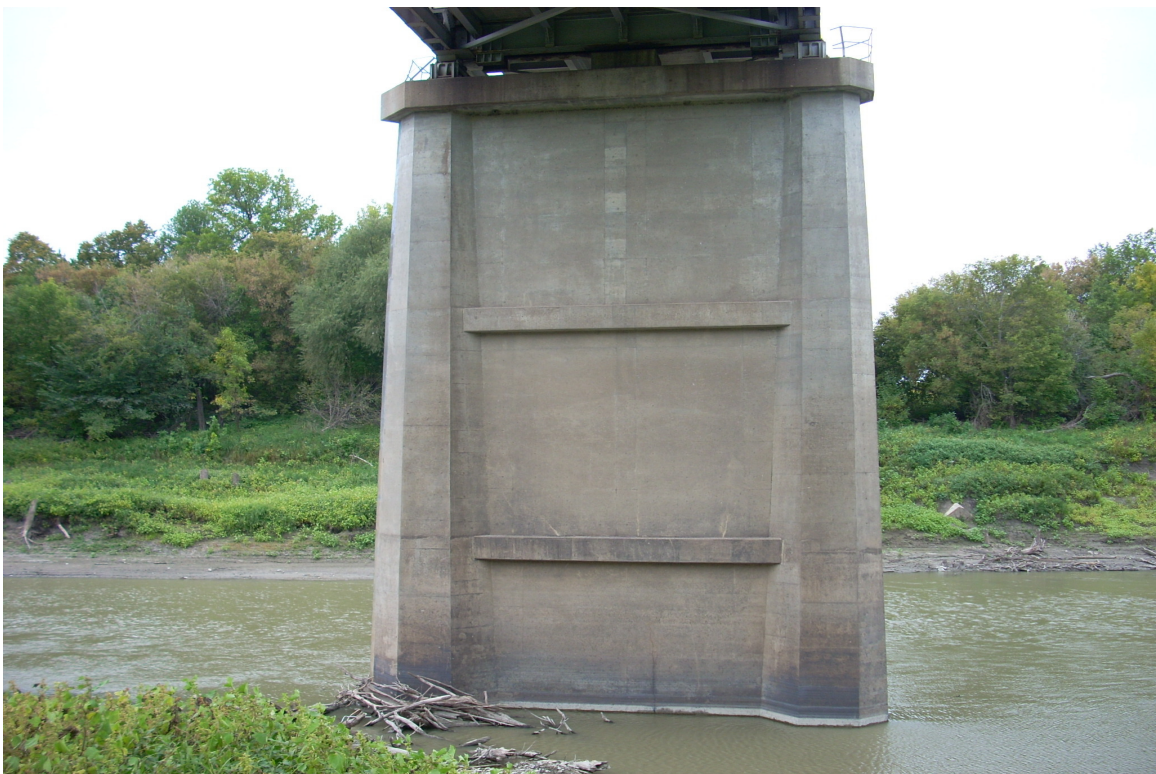
Photograph 2. View of Pier 2, Looking West.

The substructure unit inspected at Bridge No. 7097, Pier 2, was in good condition with no defects of structural significance observed. The channel bottom appeared to be stable with no evidence of significant scour.

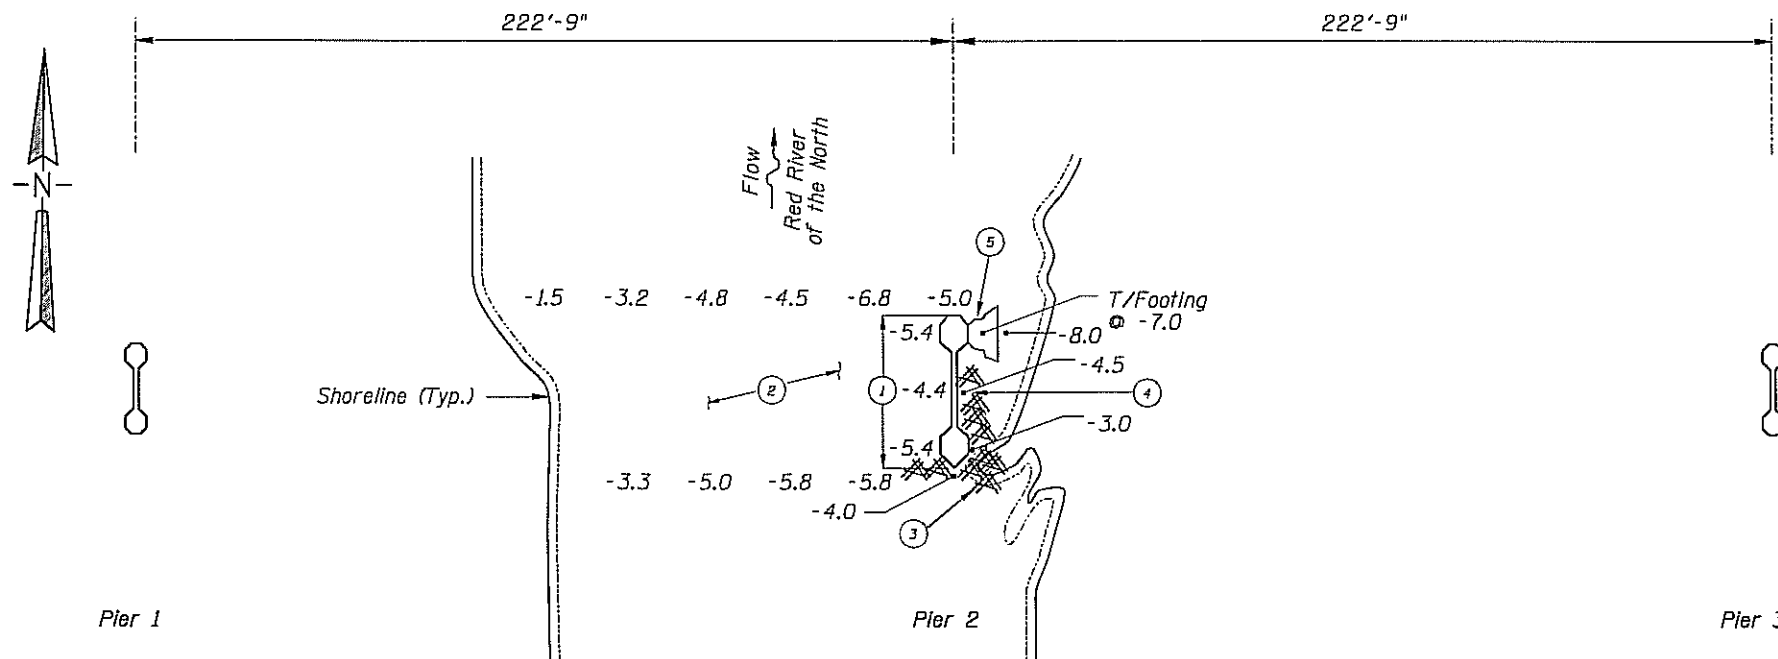
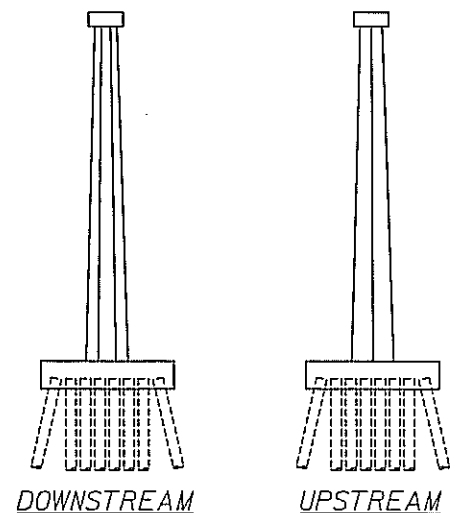
INSPECTION AND SOUNDING PLAN

- ① Overall, concrete was smooth and sound with no significant defects.
- ② The channel bottom consisted of soft silt with 2 feet of maximum probe rod penetration.
- ③ Moderate to heavy timber debris consisting of logs and branches 2 feet in diameter and smaller was observed at south end and east face of Pier 2. The debris extended from channel bottom to 3 feet above waterline and 6 feet off the east face and 10 feet off the upstream nose.
- ④ Vertical crack 1/8 inch wide extending from strut to channel bottom was located at midpoint of pier on east face of Pier 1.
- ⑤ Footing exposure at north column of the pier on east side with a maximum vertical exposure of 1 foot.

- (A) Monitor the timber debris, and if found to be increasing in the future, removal operations may become warranted.
- (B) Reinspect the submerged substructure units at the normal maximum recommended (NBIS) interval of five (5) years.
